T2 Laboratories Explosion Damage Assessment

Presenter: Ben Harrison, P.E., ABS Consulting, 14607 San Pedro Suite 215, San Antonio, TX, 78232, phone (210) 495-5195, fax (210) 495-5134, bharrison@absconsulting.com

The CSB approved this paper for release and presentation at the 2010 DDESB Explosives Safety Seminar.

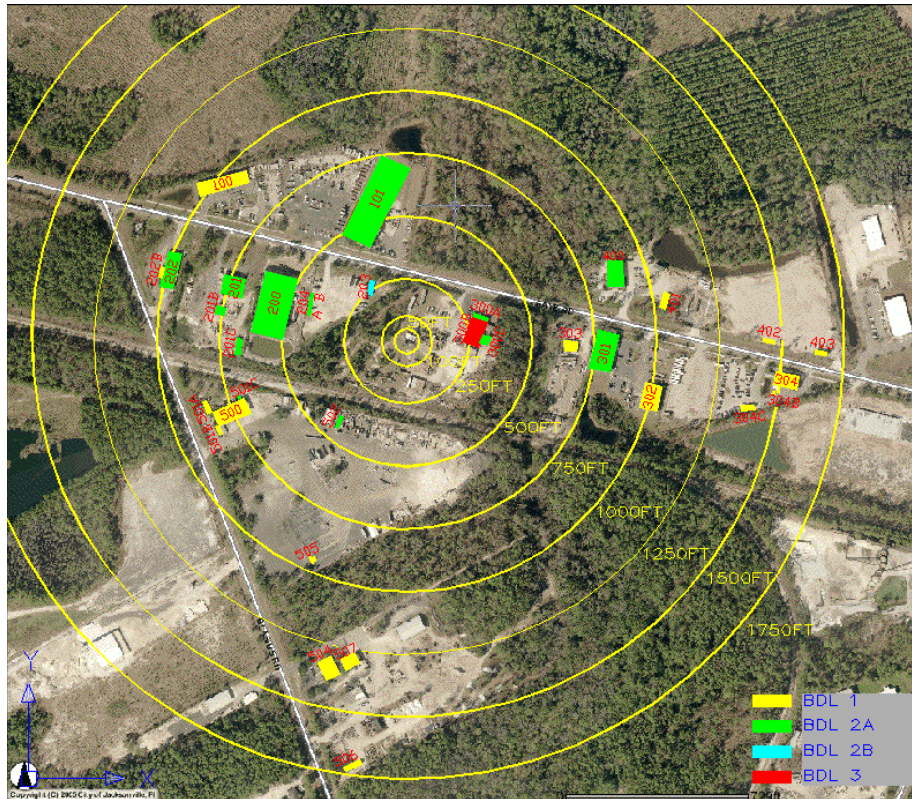
Figure 11. Map of ERASDAC Qualitative Building Damage

Building damage levels were assigned to each building based on observed and measured damage and are summarized in Table 7. A graphical map showing ERASDAC and SBEDS qualitative building damage levels is given in Figure 11 and Figure 12, respectively. Side walls and back walls which were significantly deformed outward due to blast loads entering the building envelope through large roll-up doors were not considered in evaluating building damage levels. This is because the methodologies utilized are for assessing buildings subjected to external blast loading. Inspection of Table 7 shows that

the potential exists to cause structural damage well beyond K40 separation. Two large pre-engineered warehouses (Buildings 101 and 200) located at K50 were condemned as a result of the explosion.

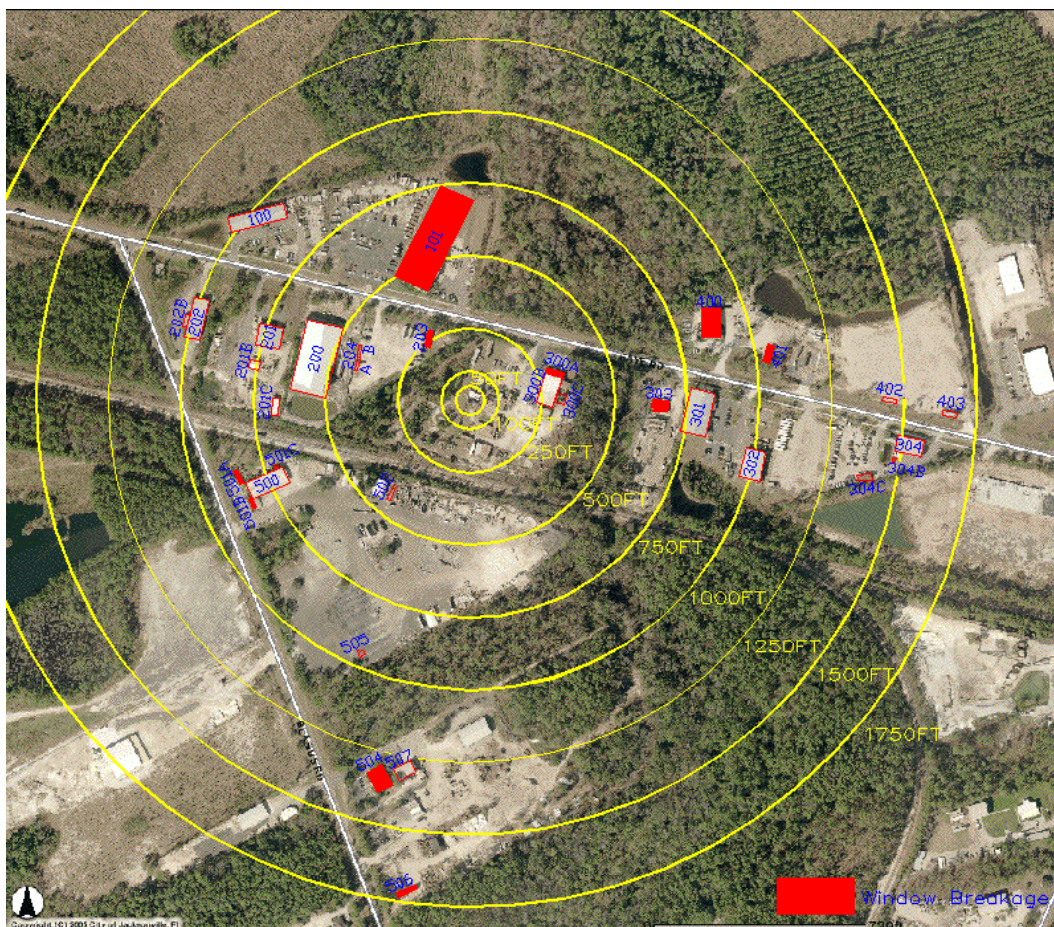
Figure 13. Map of Off-Site Window Breakage

ABS Consulting surveyed windows which broke in the incident up to the structural damage extent at 1,750 feet. A map detailing buildings with observed window breakage is shown below in Figure 13.

Fragment travel of broken glazing is used to quantify the window performance condition in accordance with the Interagency Security Committee (ISC) criteria^[7] which have been adopted by the General Services Administration (GSA) and implemented in the computer software WINGARD (Window Glazing Analysis Response and Design)^[8]. ISC glazing performance conditions are described for each hazard condition in Table 8. Table 9 details the maximum hazard level observed for each building with windows. In many instances the windows had been repaired or replaced prior to inspection by ABS Consulting; however, occupants testified to which windows had broken and the extent of the window fragment travel. Table 9 shows that high hazard level (Level 5) was observed at K50, Medium Hazard Level (Level 4) was observed at up to K75 and that window damage was observed at over K100.

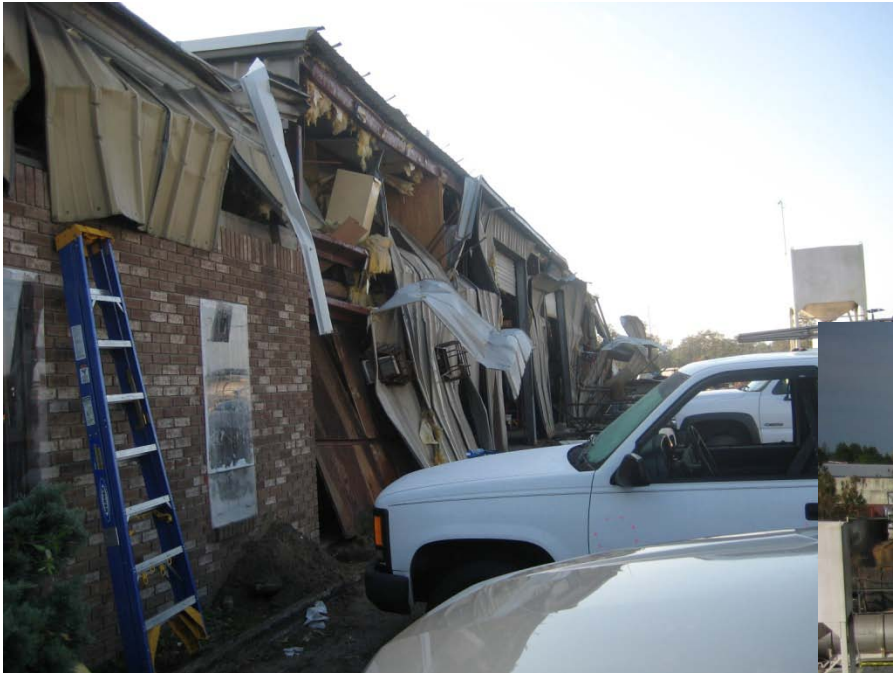
Building 300 – K25

- ERASDAC BDL 3
- SBEDS Heavy Damage

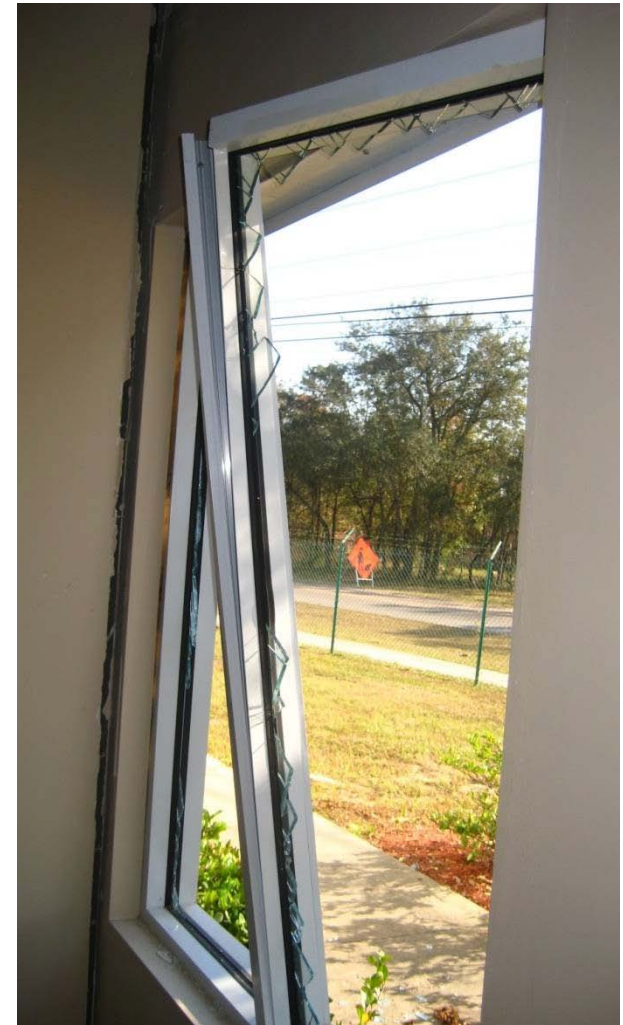
Building 101 – K50

Hazard Level 5
